Pavement Condition Assessment Report

The Legends at Santa Rita Springs

2359 S Via Massari
Green Valley, AZ 85614

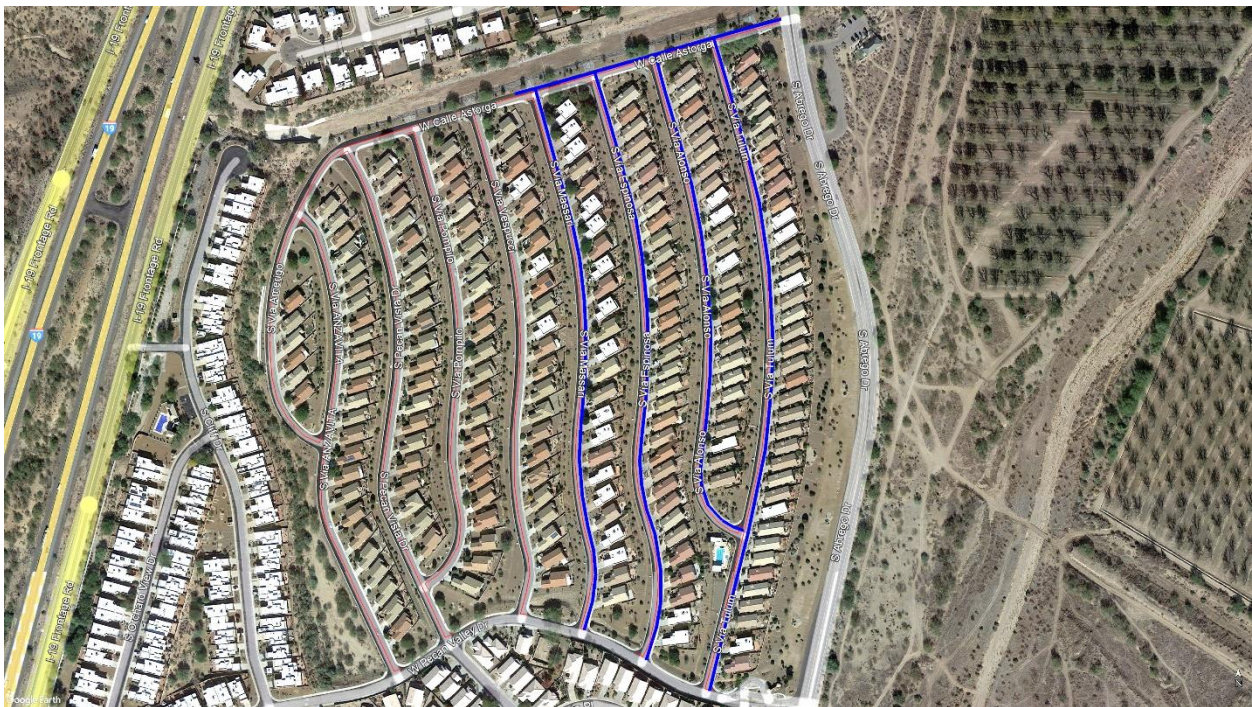
Streets Requiring Reconstruction - Blue Markings

The community streets recommended for reconstruction total approximately 196,508 square feet.

The eventual reconstruction of specified streets will require a 3-inch removal depth and a minimum 3-inch replacement with possible subgrade stabilization prior to repaving.
